### Report on the Vibration tile performance tests

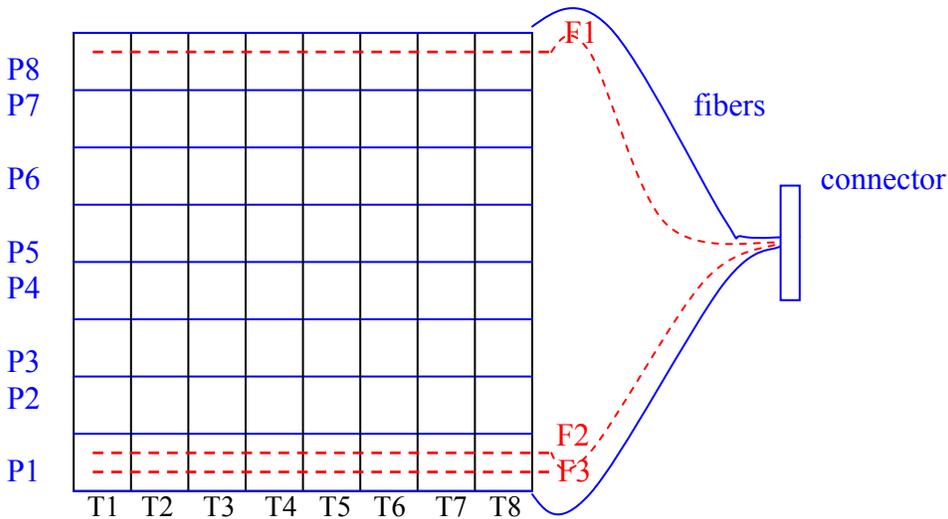
**Fig.2. Mapping of the tested tile.** Blue lines show X-direction hodoscope, which is along the fibers in the tile, with corresponding hodoscope strip numbers (P1 to P8, in blue), and black lines show the Y-direction hodoscope (across the fibers), with

corresponding strip numbers T1 to T8, in black. Dashed red lines labeled by F1, F2, and F3, show damaged fibers (see section below). P2 hodoscope strip did not work, so the measurements for P2 are missed in the plots.

**The tile.** Before the vibration tests the tile was checked visually on the subject of defects. It was found that 3 fibers had defects – fiber F1, which is just the edge fiber, is semi-broken (has a sharp kink), fibers F2 and F3 (the very edge and the next to it) have bright rings. These rings indicate the cracks in the cladding; there could be some light leak through these cracks out of fiber (believed to be a minor effect). These defects probably occurred during tile shipping from FNAL, because these tiles have not been annealed before shipping. The annealing is a mandatory procedure, and these tiles were annealed here at GSFC after receiving.

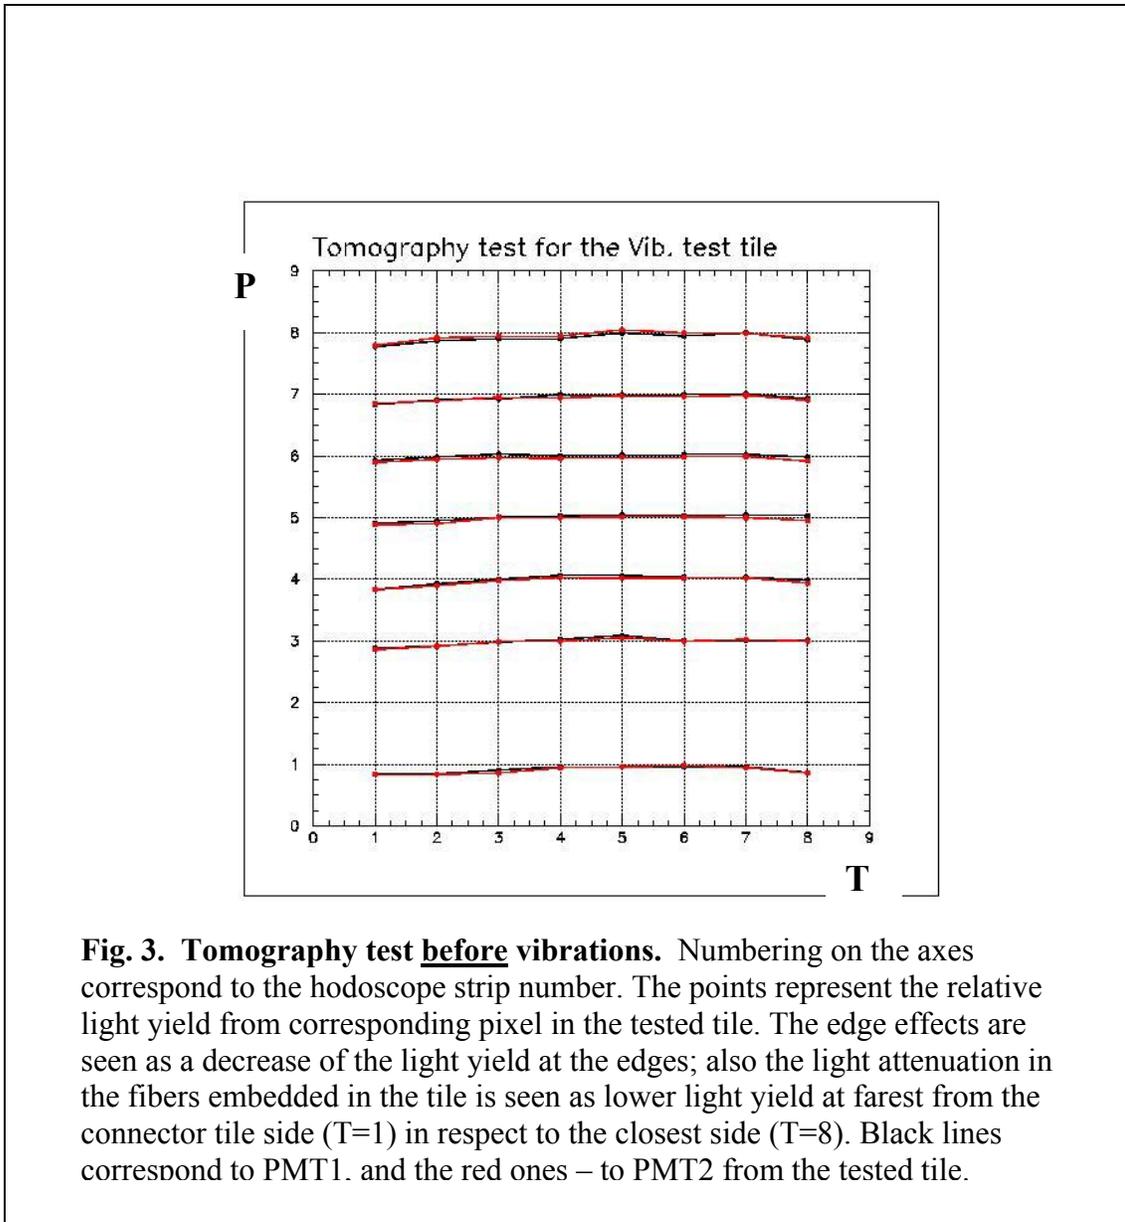
**Fig. 3. Tomography test before vibrations.** Numbering on the axes correspond to the hodoscope strip number. The points represent the relative light yield from corresponding pixel in the tested tile. The edge effects are seen as a decrease of the light yield at the edges; also the light attenuation in the fibers embedded in the tile is seen as lower light yield at farthest from the connector tile side (T=1) in respect to the closest side (T=8). Black lines correspond to PMT1, and the red ones – to PMT2 from the tested tile.

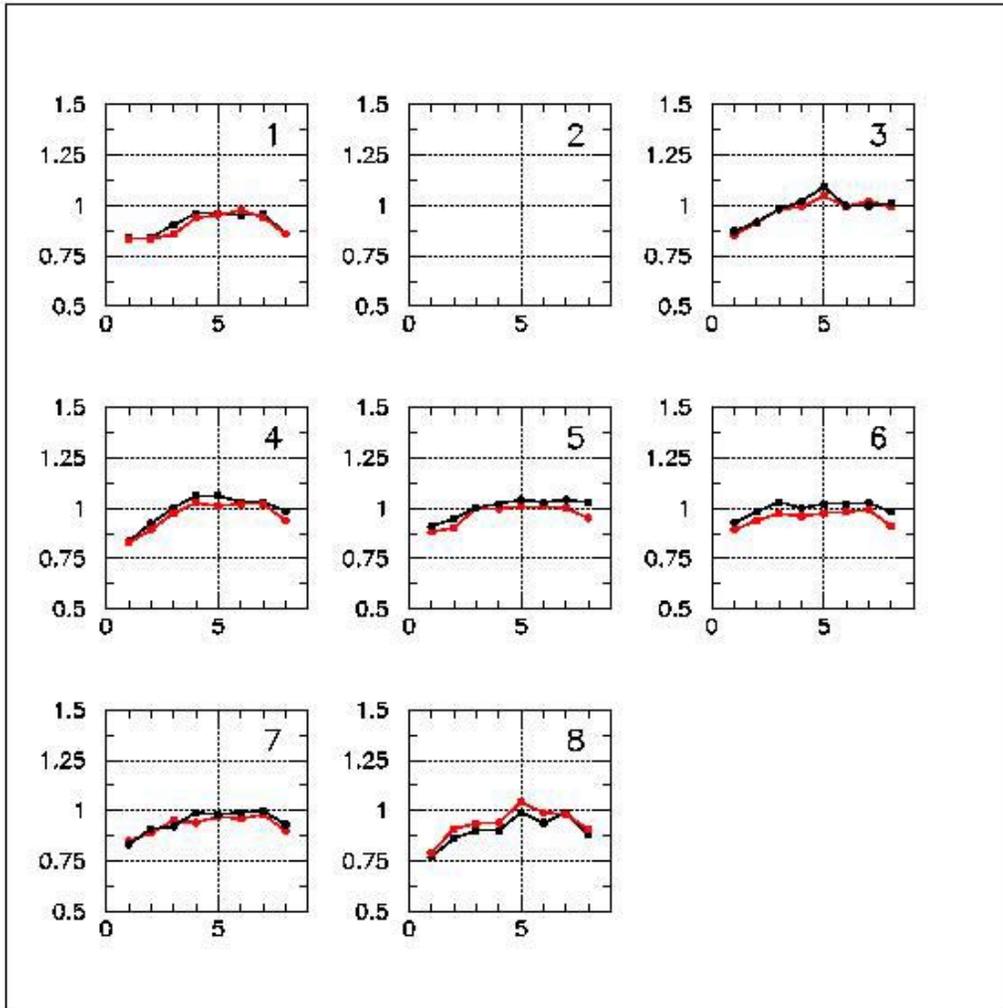
**Fig.4 . Light yield mapping before vibrations (detailed view).** Each box corresponds to single X-direction strip (P) with the number provided in the right upper corner of each box. The numbers of T-strips are given at X-axes of the plots.

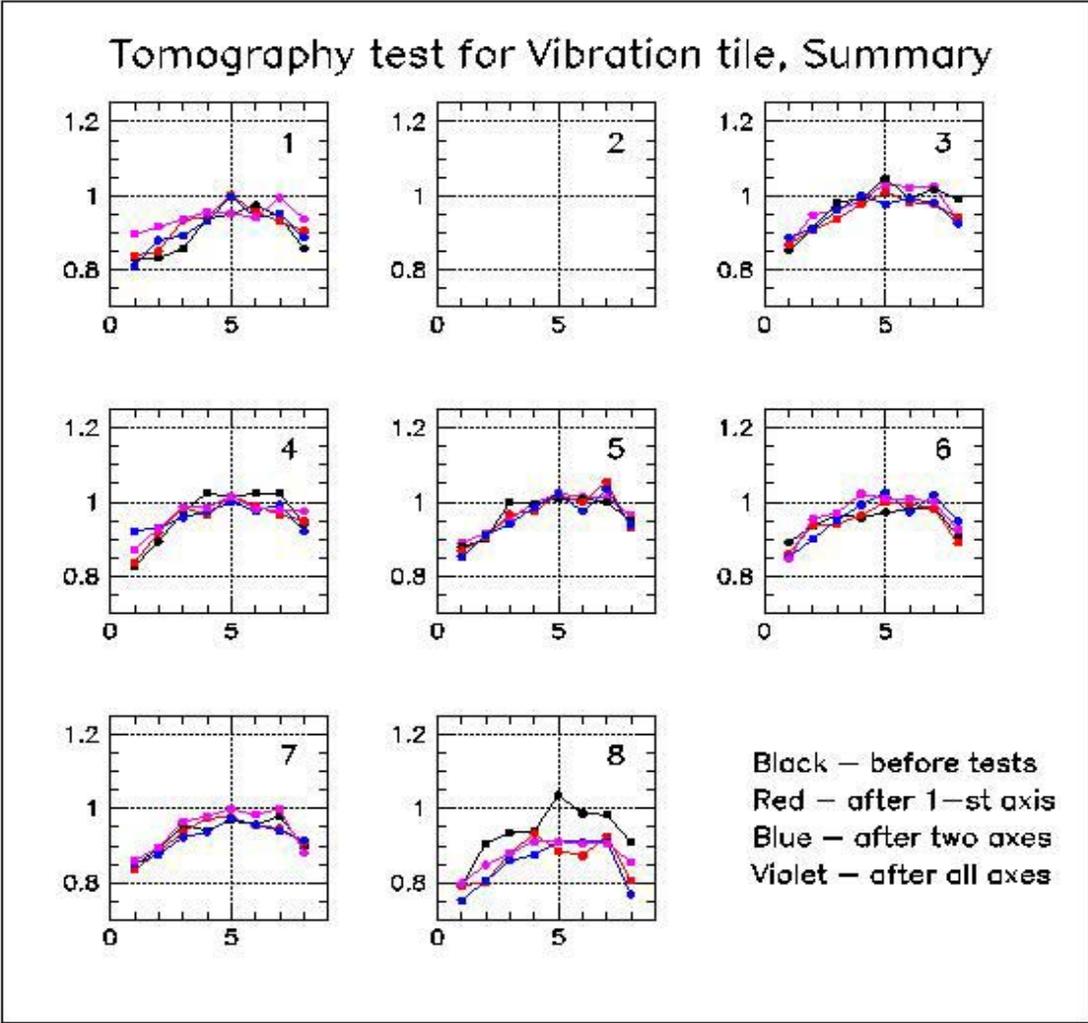
**Fig.8. Comparison of the light yield through all vibrations (resulting plots)**

**Conclusion.** The tile was unwrapped and visually inspected between all vibration regimes and after all vibrations completed. **No visible changes in respect to that observed before the tested have been found.** Looking at the resulting measurements plots in fig.8, we can conclude that the light yield through the vibrations is **well within required 10% variation, meaning that the tile successfully passed the vibration tests.** There is one concern about panel 8 in fig.8 where the initial light yield (black line) is approximately 15% higher than all others. This box corresponds to the area where the “semi-broken” fiber is located. I can explain this light decrease by increasing crack in a fiber which was already broken before the vibrations. I believe this is completely understandable effect, and it occurred only because the fiber was already broken. If it would not so, there would be a reason to consider the test failed.
