# **Failure Analysis of Failed PMTs**

## **Progress report**

# Disassembly of Failed PMTs

# Fracture Origin of AA0393

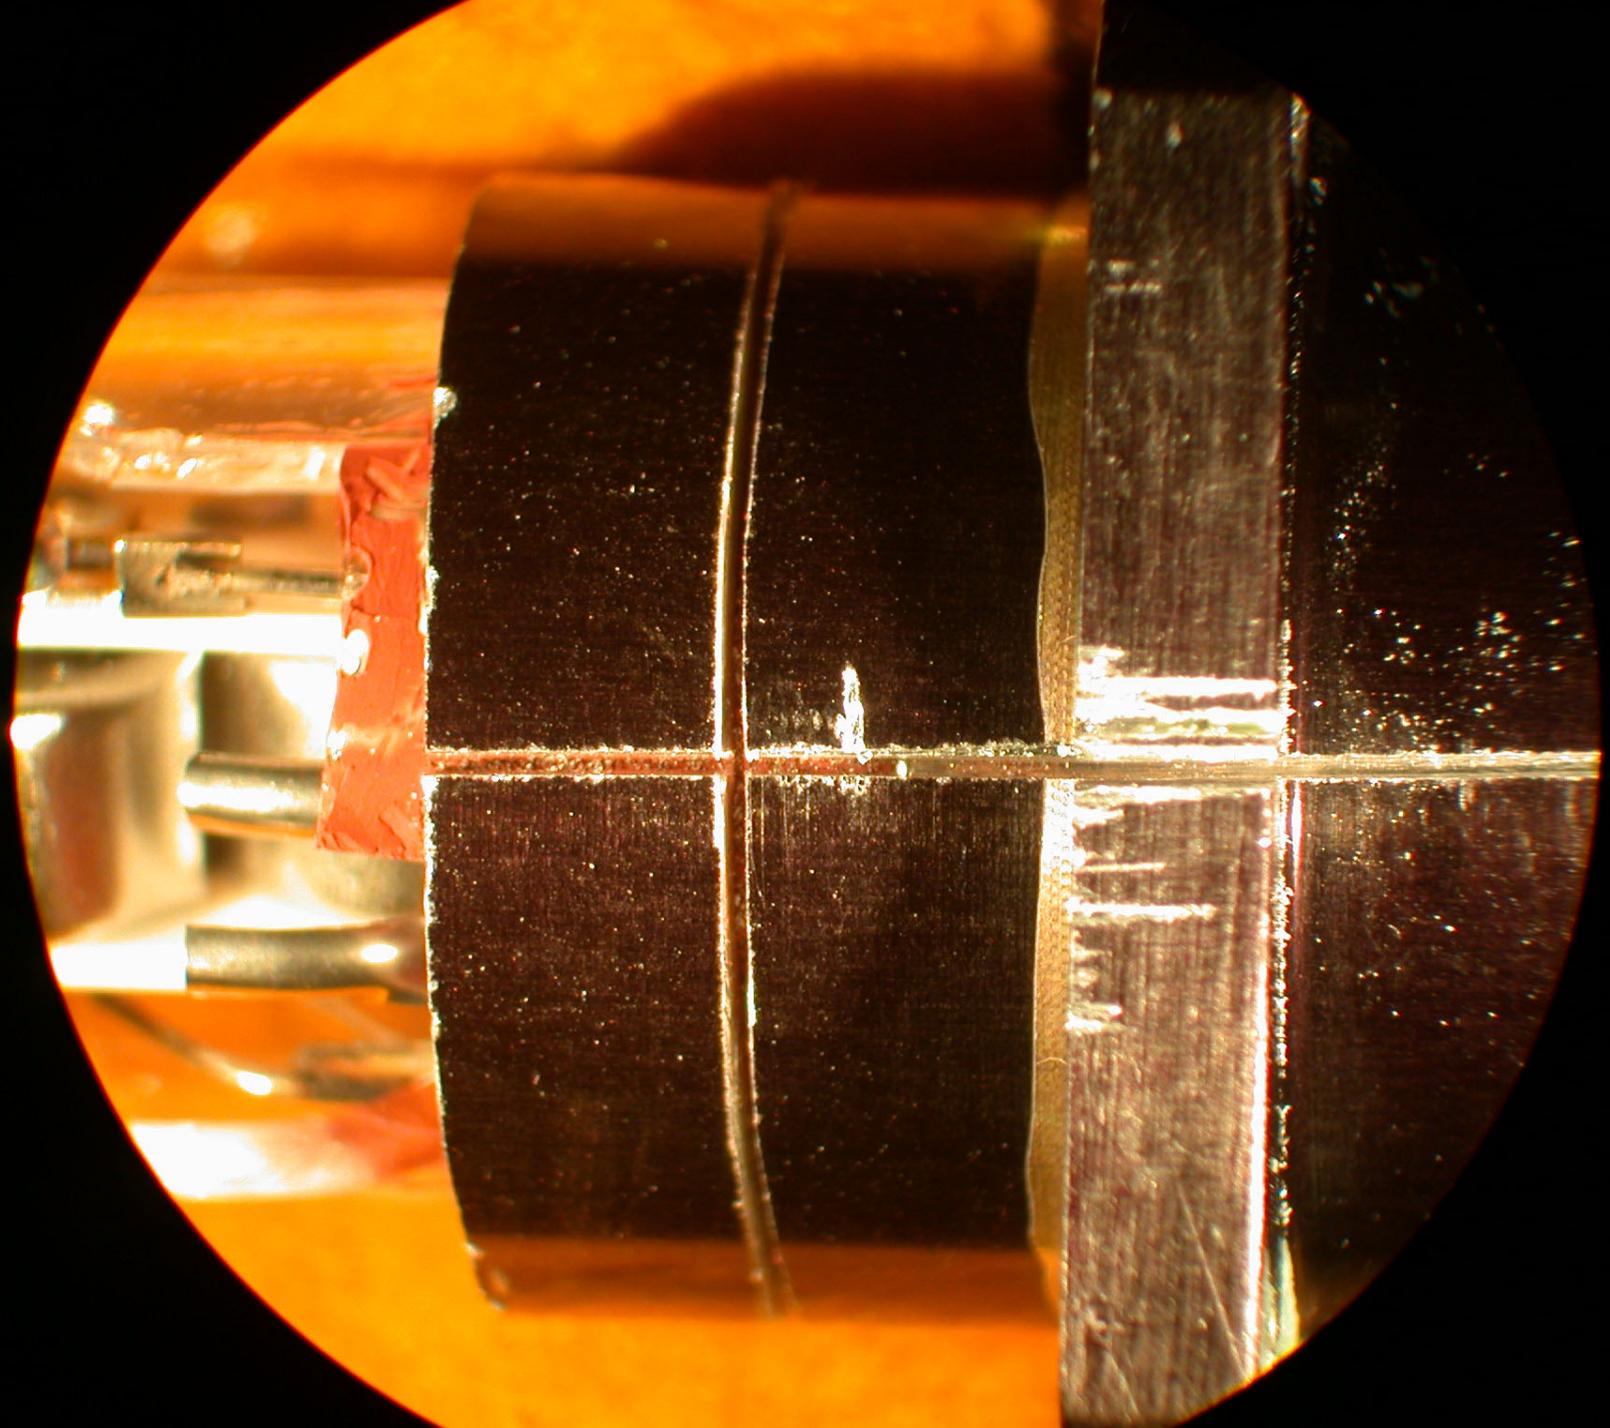
- Two are being worked on
- Identified fracture source for one (AA0393 NG PMT, by Walt Thomas)
- Small amount of bubbles in RTV, most < 1 mm.
- RTV bonds better to glass than to aluminum housing, varies from assembly to assembly

1 mm

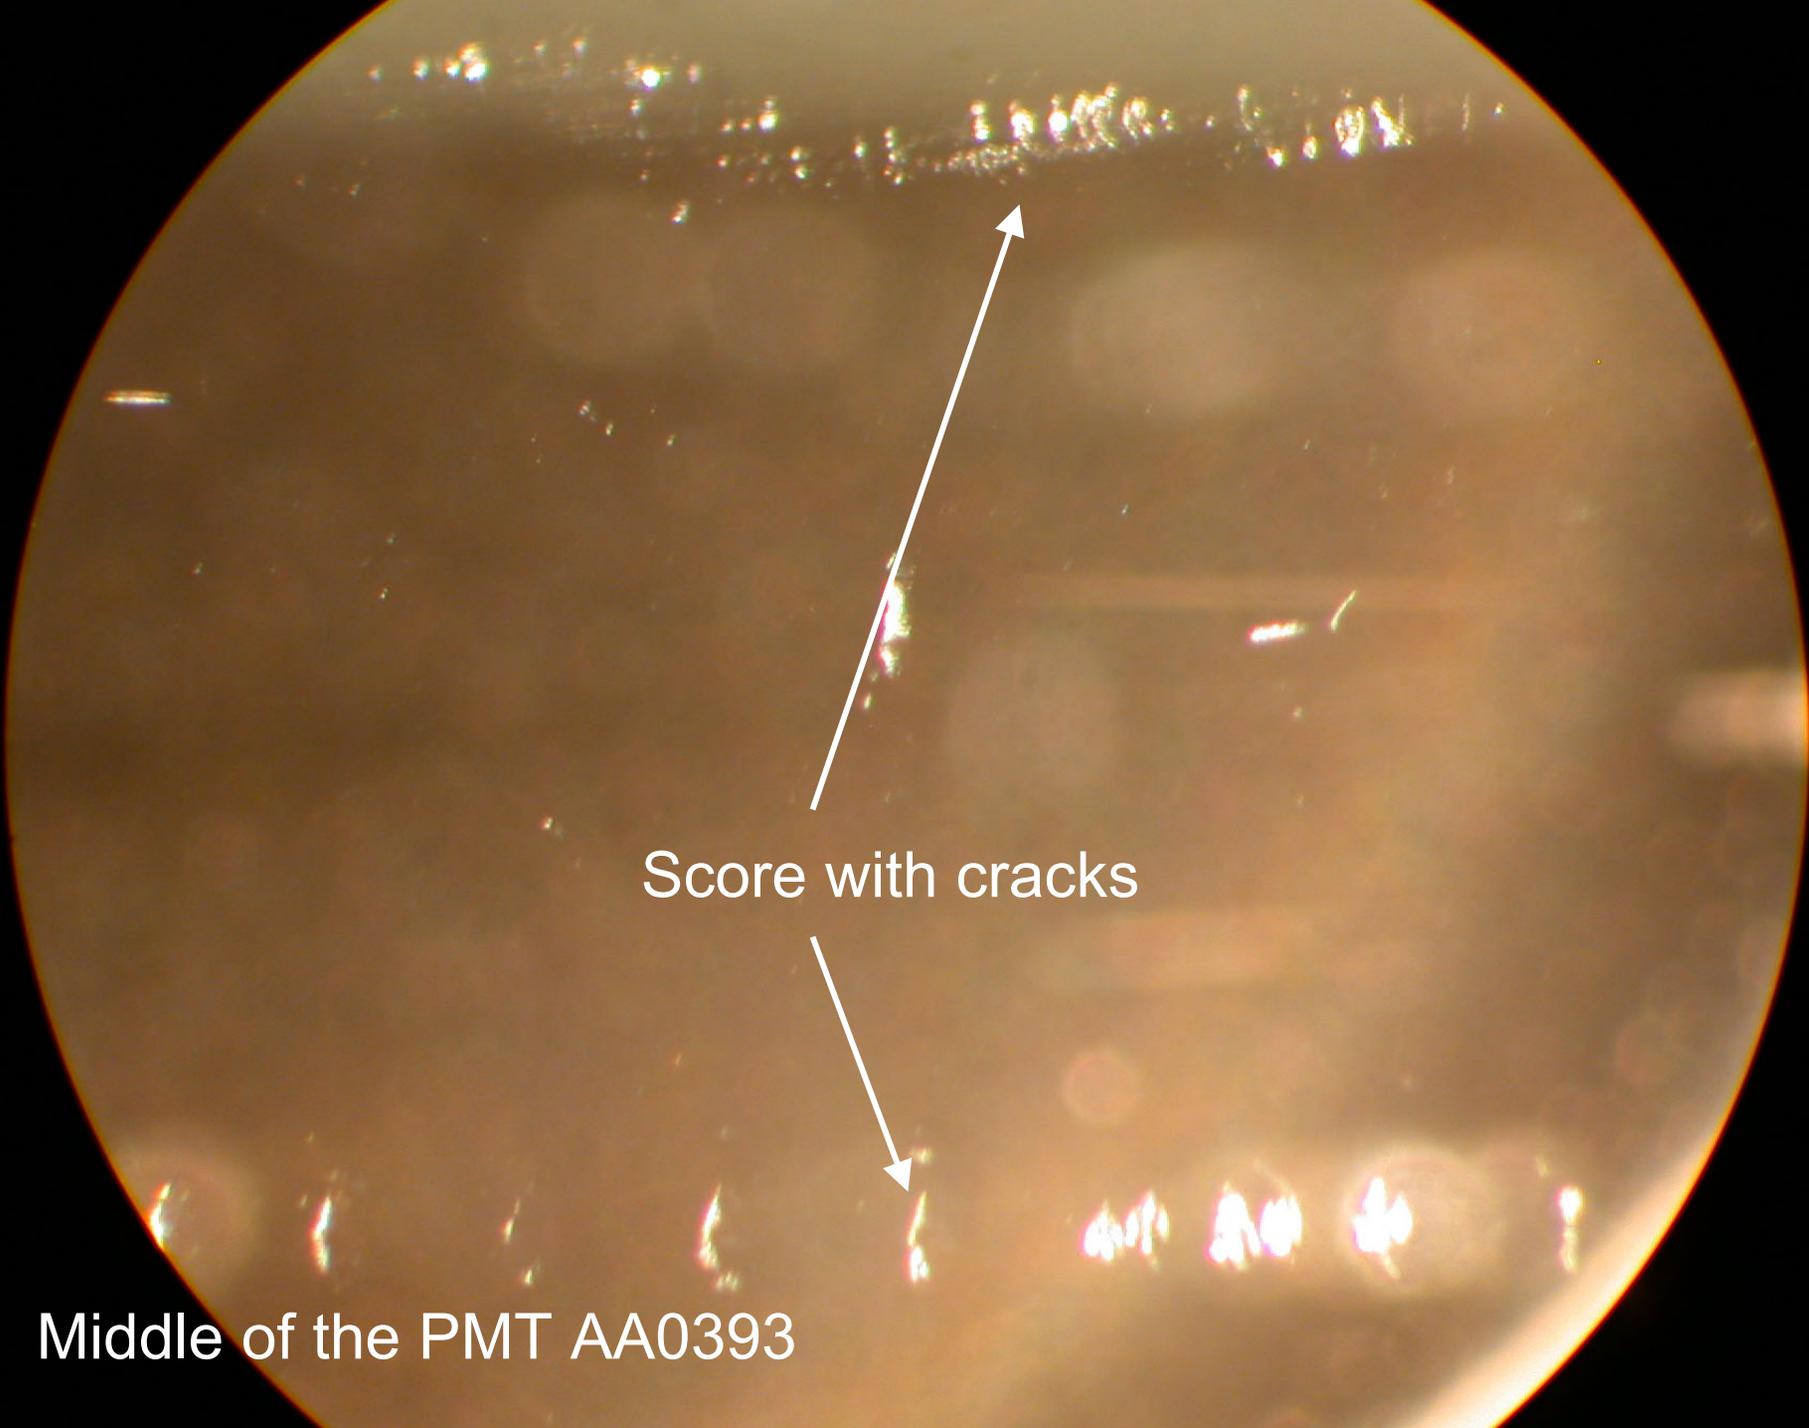
Middle of the PMT AA0393

Score with cracks

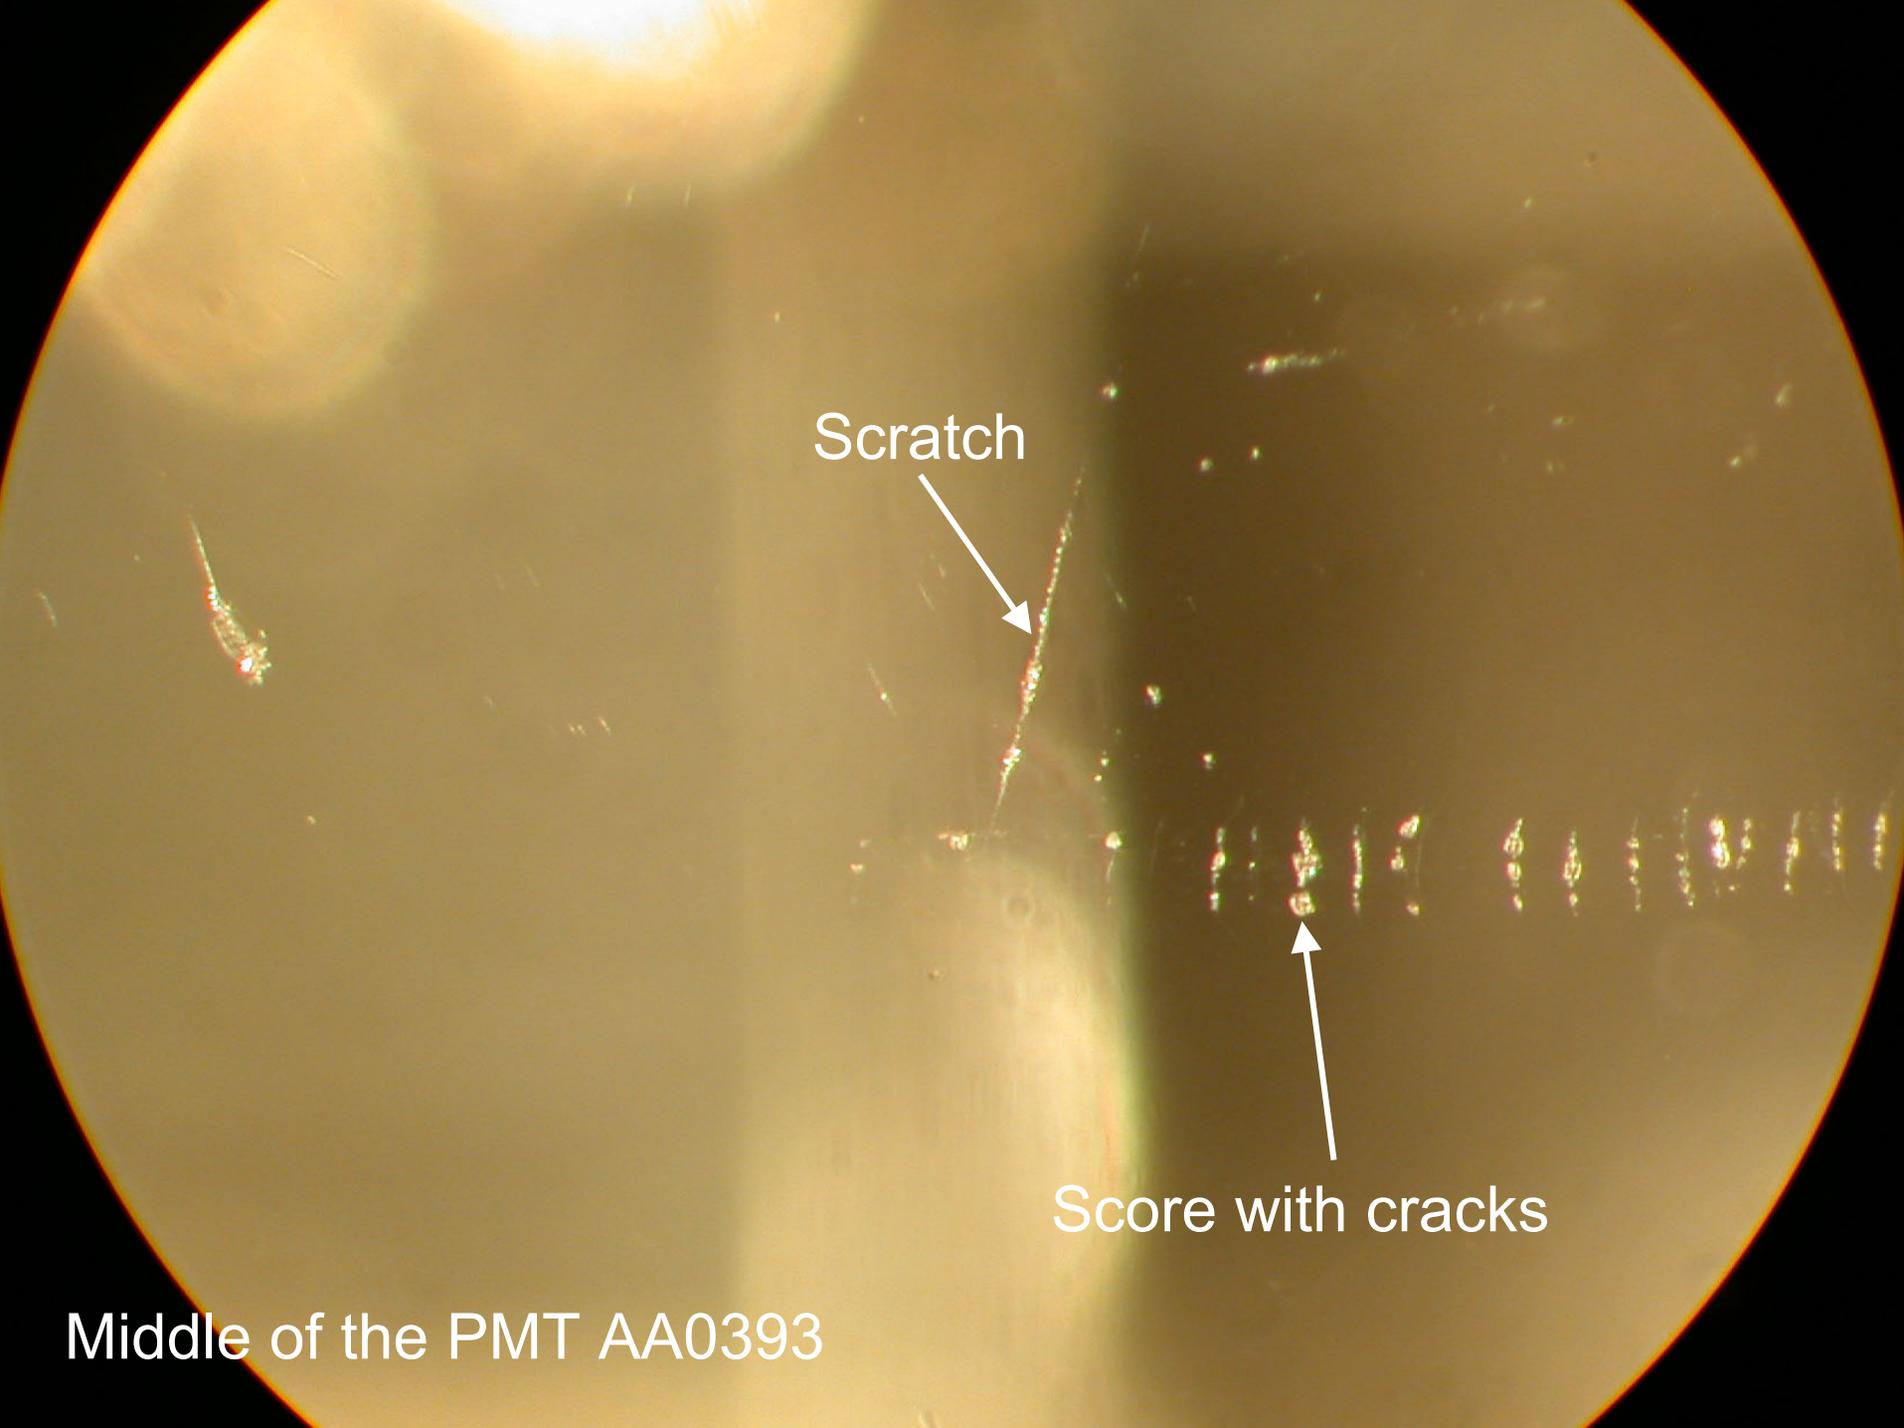
Middle of the PMT AA0393

Scratch

Score with cracks

Chipping due to cutting

Wallner lines

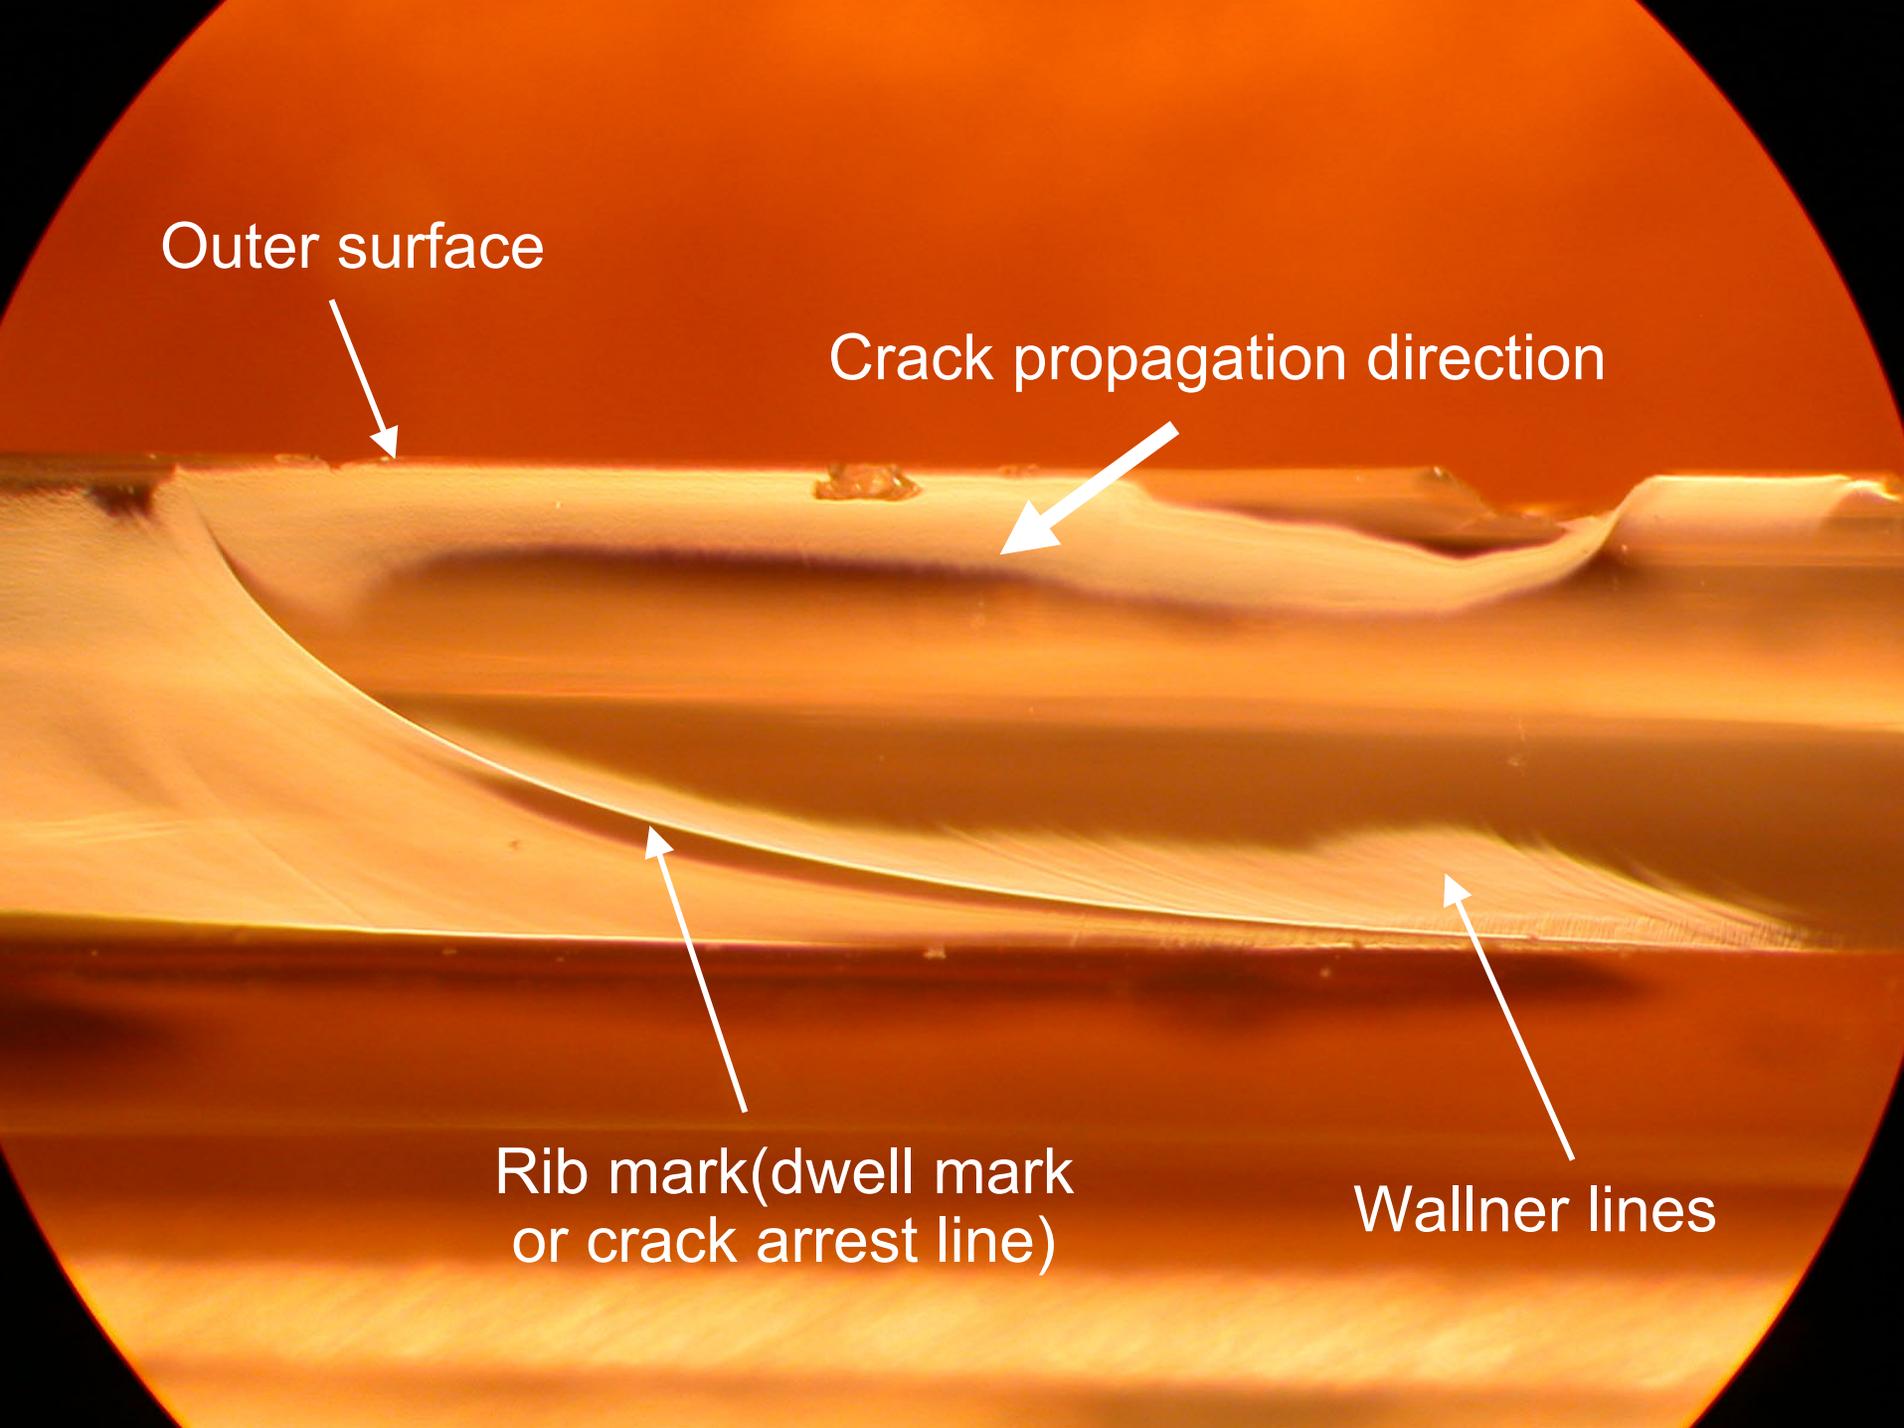
Outer surface

Crack propagation direction

Wallner lines

Rib mark (dwell mark  
or crack arrest line)
