# **ACD PMT 0046 Engineering Unit Failure Issue Summary and Status**

**Draft 3 12/08/03 – 1/20/04**

**Michael Amato**

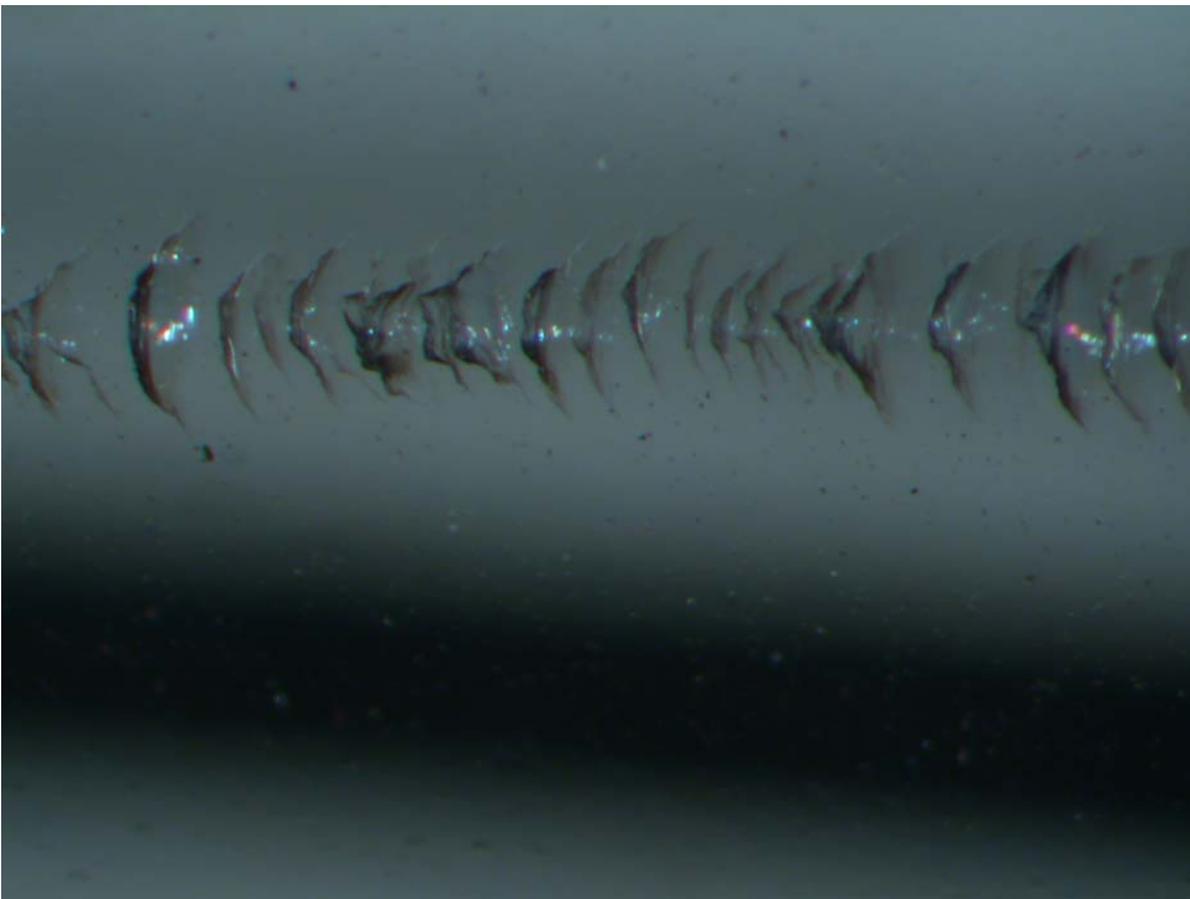
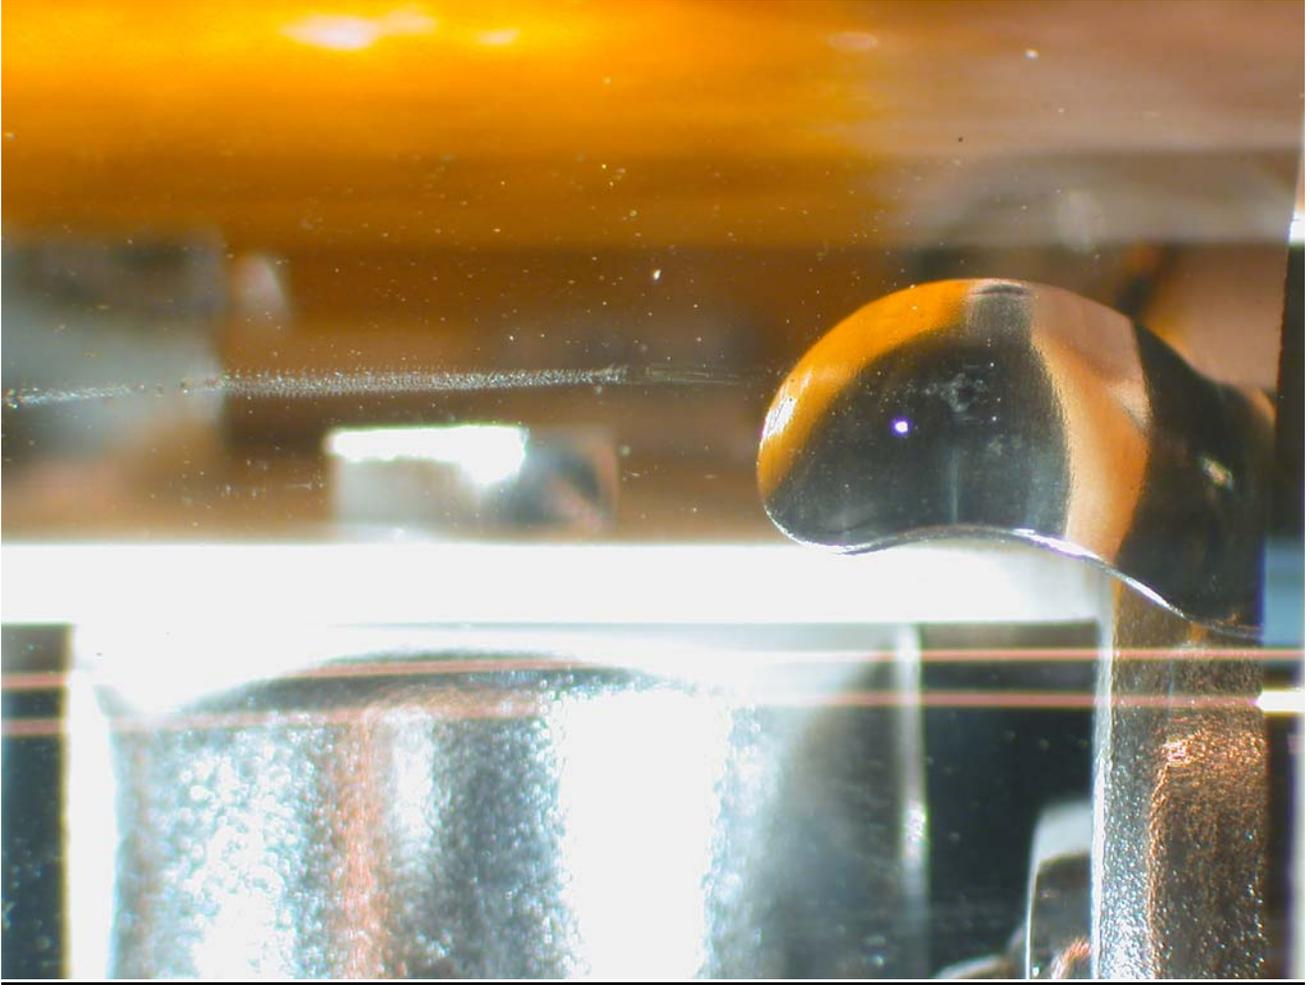
Action 17 - Flight PMT revealed some bubbles in glass. Not known if as many as Cal units because a more serious flaw was discovered. This flaw is a score along the inside of the tube all the way up almost certainly due to flex lead riding up tube during PMT internal electronics insertion. The broken PMT (46) was inspected and the visible part of the crack is at the same orientation as the score would be on that tube. The first failed tube that underwent excess clamping force was also inspected to check

for the score. It was there and the crack in that PMT originated from the score. Removal of the housing will tell if PMT 46 failed at the score or not.

Figures of 'score' flaws below

*Action 21* – All 5 flight PMT tubes brought to materials have 4 scores along the inside of the tube almost certainly caused by the pressure tabs during insertion of the tube inside components. The scores might average ~80? microns in length and ~50? microns in apart. The depth into the glass is not measurable but past experience might suggest they could be approximately half the length or ~40? Microns. Some additional minor features were noticed on one of the tubes. Some particulate metallic contamination was noticed inside the tube. Hamamatsu specs do allow some metallic contamination if they are under a certain size. The inspection specs also allow for the ‘bubbles’ that are observed in the window to tube interface as long as they are under a certain size. There is some question on how they inspected the thousands of bubbles in each tube. Materials speculated that these tubes could well have very humid air in them which greatly accelerates crack propagation. However the bubbles are still thought to be a much smaller risk when compared to the scores. It appears from testing of an earlier PMT fragment that the PMTs do have built in internal stress fields, but another test may be necessary to get more information.

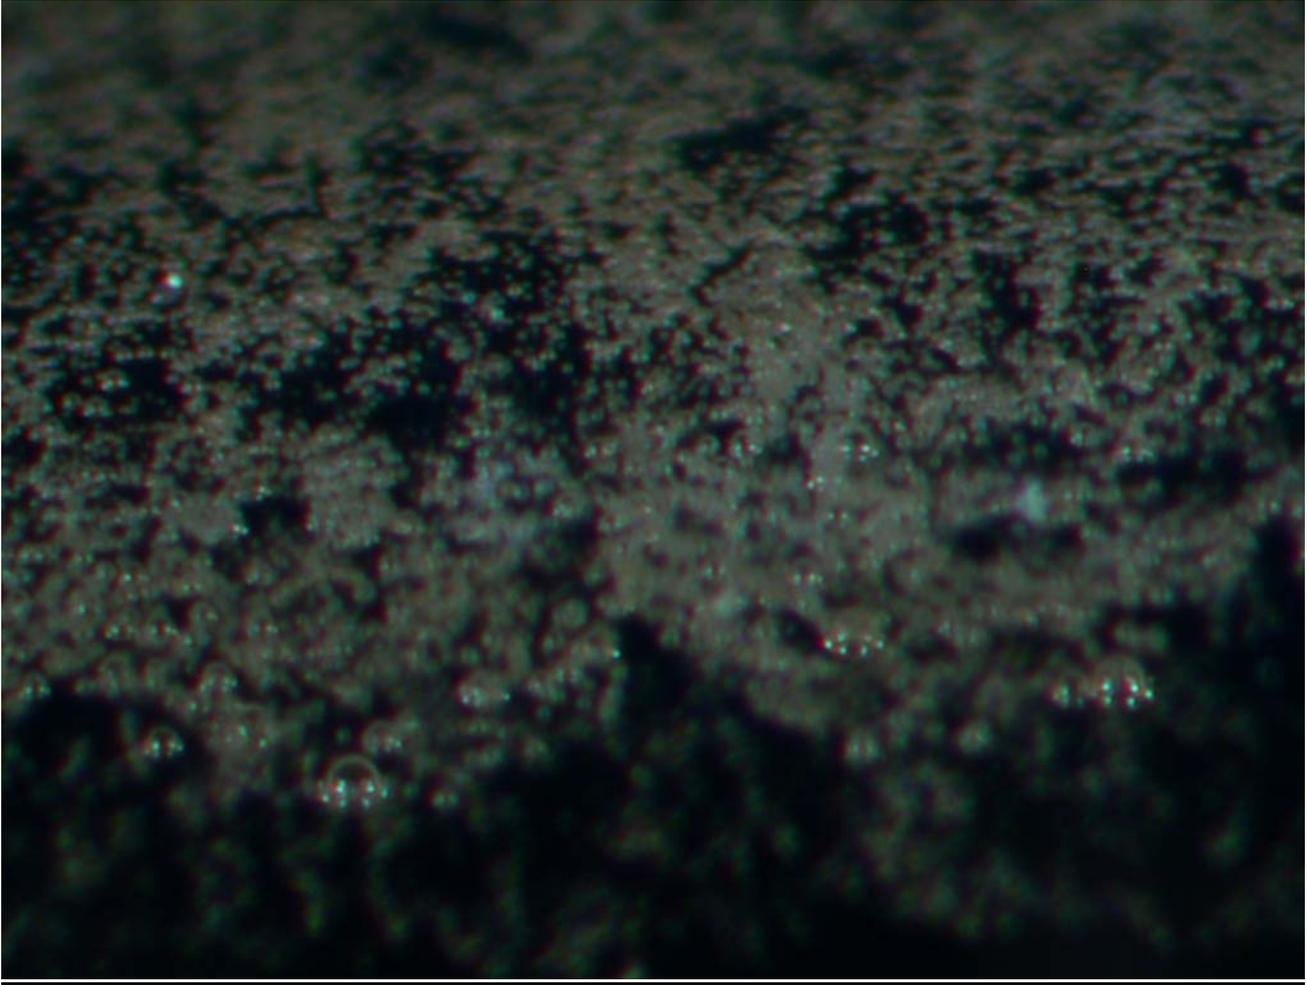
Figure of less serious 'bubble field' at tube to window interface
