# TDA flexure to fiber gap margin and interference problem

## Trade Study notes

# Anti-Coincidence Detector

### Report to SLAC on Nov. 18, 2003

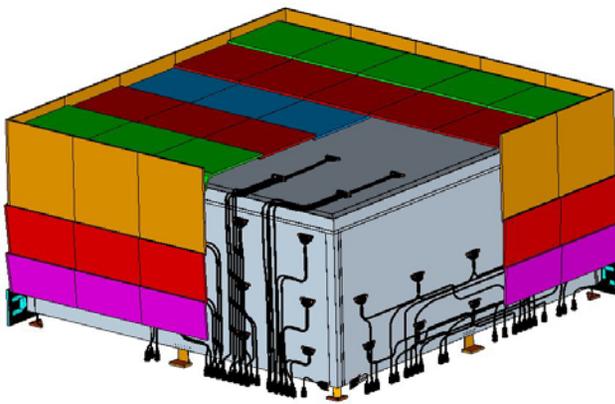
- TDA to TSA Mounting Issues

- TDA Waveshift Fibers (WSF) to TSA Flexure Spacing Issue

+X – Affects 65 of 89 tiles (Yellow)

- 3<sup>rd</sup> Row TDA WSF to Bottom Tile Flexure Interference Issue

- Affects Remaining 24 of 89 tiles (Blue)

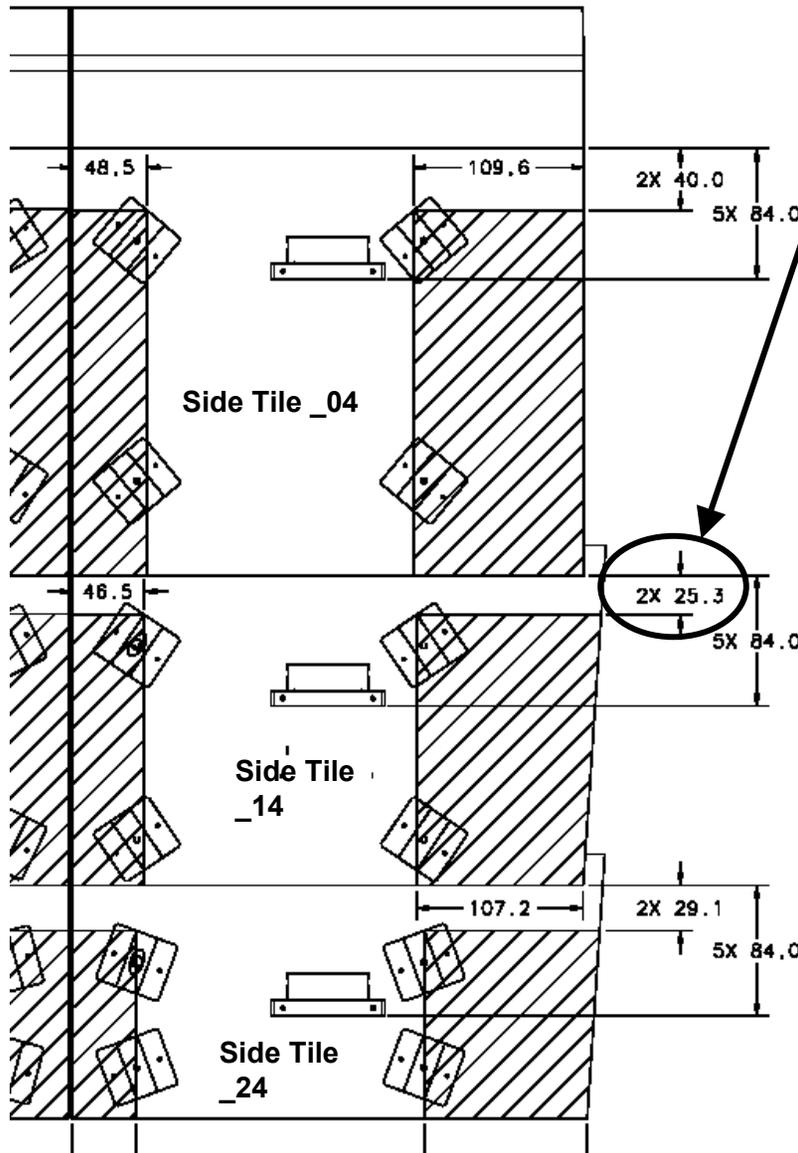
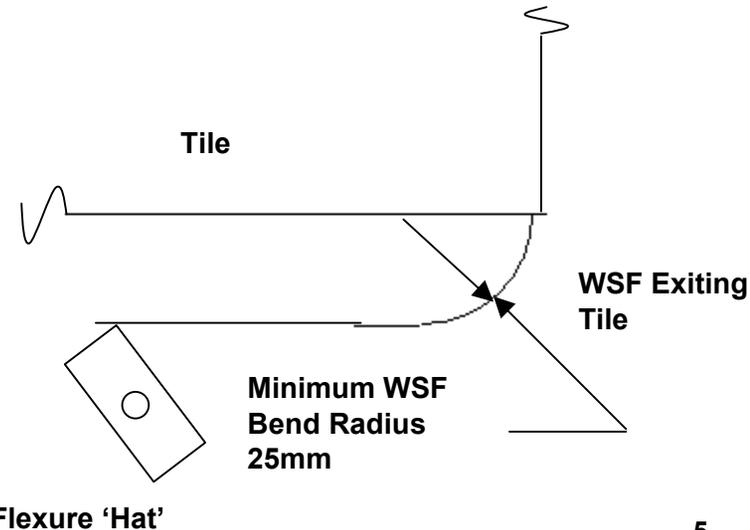
# Tile Spacing Issue – Worst Care

## **•BIGGEST CHALLENGE**

**•Spacing Between Crown Tile (Row 1) and Row 2 Tile Flexure (Upper) :**

**•25mm WSF Bend Radius Spacing was the Design at the Time Issue Was Found**

**•Brings the WSF too Close to Tile Flexures.**

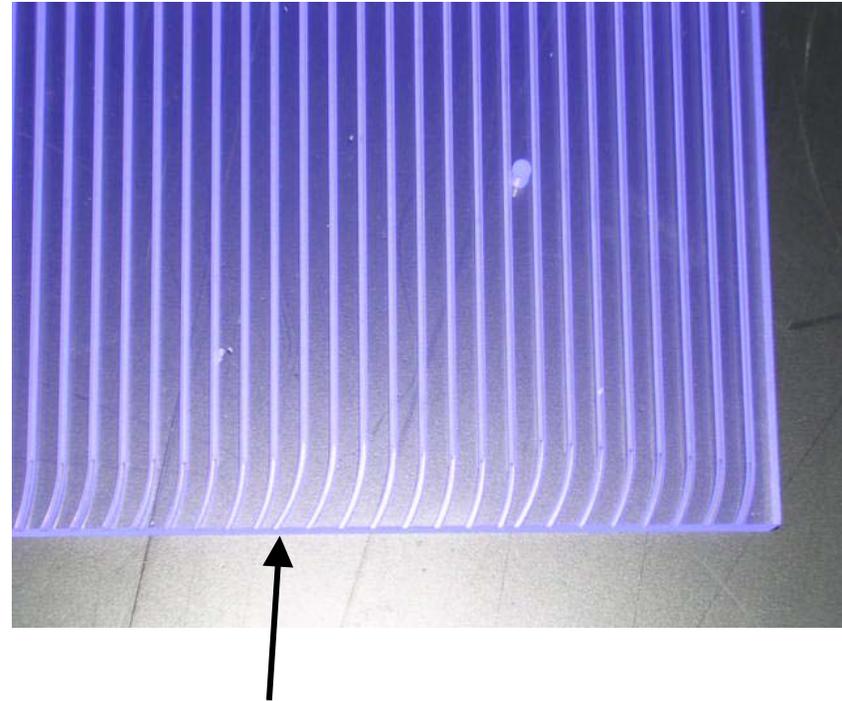
Instead of WSFs Exiting Straight Out Tile Edge (Prior Design), a Groove in the Tile Initiates the WSF Curve 20mm Sooner.

- ✓ Establish Design Envelope Between TDAs and TSA Mounts.
  - ✓ Worked With FERMI to Establish Acceptable TDA Envelope
    - ✓ FERMI Changed How the Fibers Exit the Tile
- ✓ Moved Upper TSA Flexure Mounts 5mm for Row 3 TDAs
  - ✓ Tile Edge to Tile Flexure is Now 30.3mm

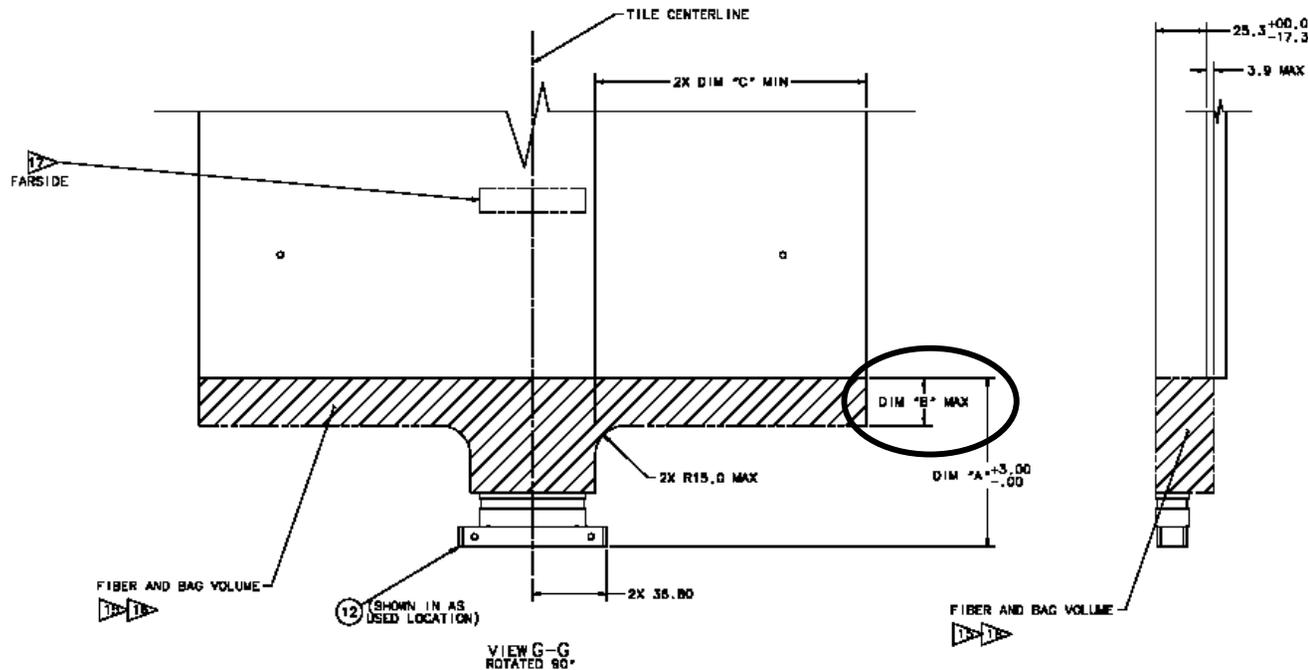
# TDA Envelope Drawing

- Smallest Tile to WSF Envelope (X-Hatch) Dim 'B' is now 23.7mm (MAX)
- Smallest Tile Edge to Tile Flexure is now 29.1mm
- Minimum of 5.6mm Clearance is now Achieved.

- Revised TDA Drawings to Define TDA / WSF Envelope

- Conforms the Numbers (Dim B) FERMI Demonstrated and Agreed with.

- TDAs Inspected Prior to Delivery.

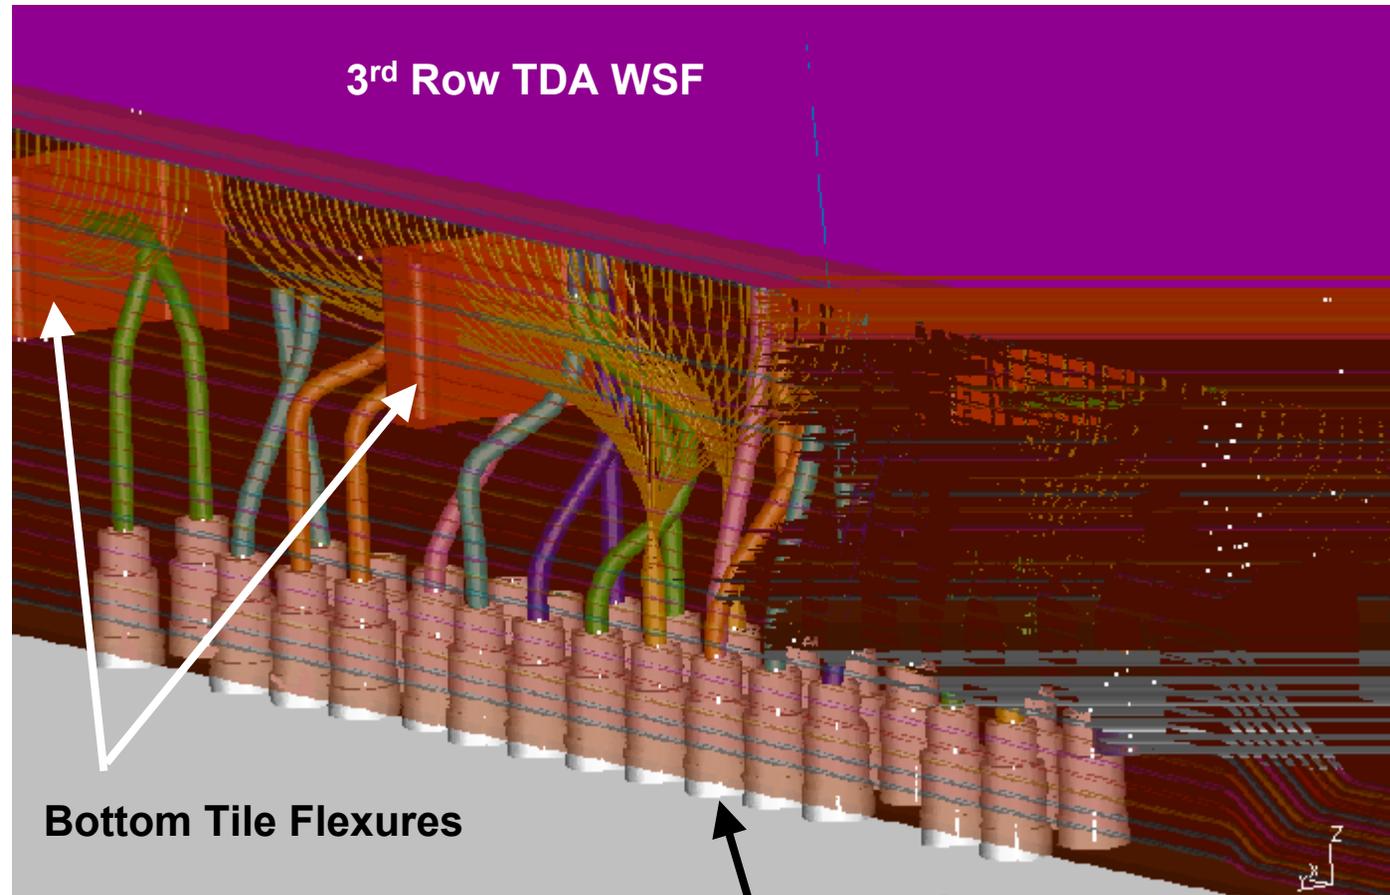
- The Bronze Colored WSF Interfere with the Bottom Tile Flexures Shown

- Note: The WSF terminate directly into the PMTs
