# **GLAST Large Area Telescope: AntiCoincidence Detector (ACD) PhotoMultiplier Tube Glass Failure**

**NASA Goddard Space Flight Center**

**March, 2004**

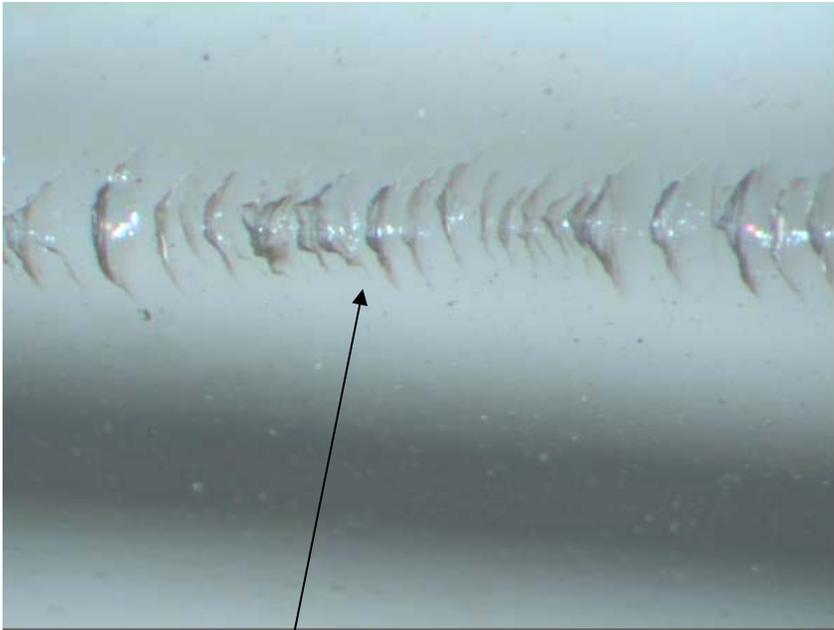
Close up of one score line, PMT vulnerable at scores

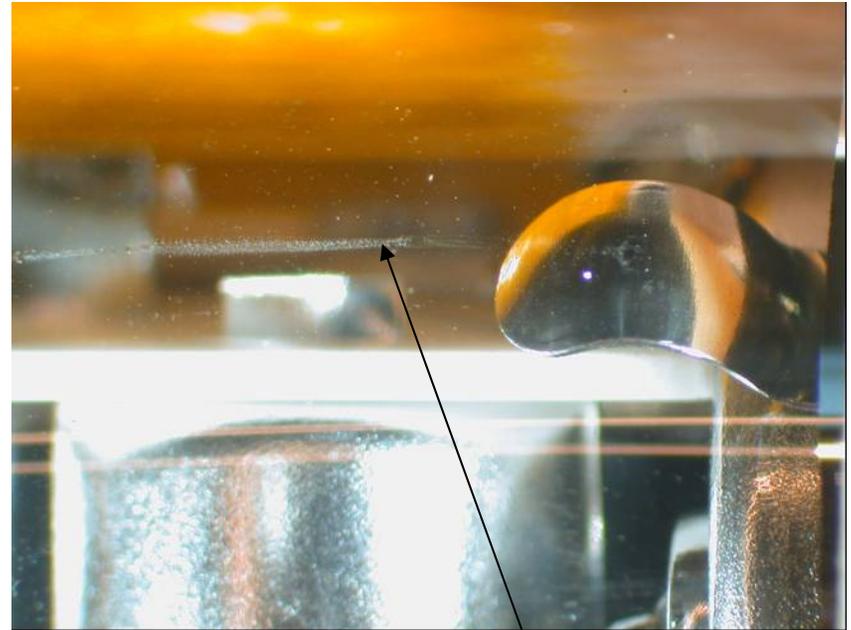
Score line ending at dynode mount

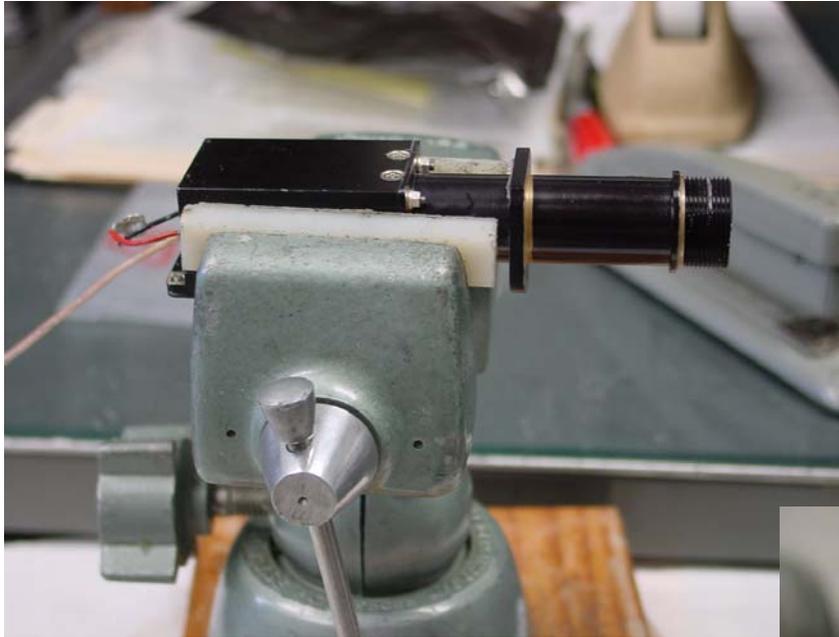
Cut with handsaw and removed the housing piece by piece
