# **ACD PMT 0046 Engineering Unit Failure Issue Summary and Status**

**Draft 3 12/08/03 – 1/20/04**

**Michael Amato**

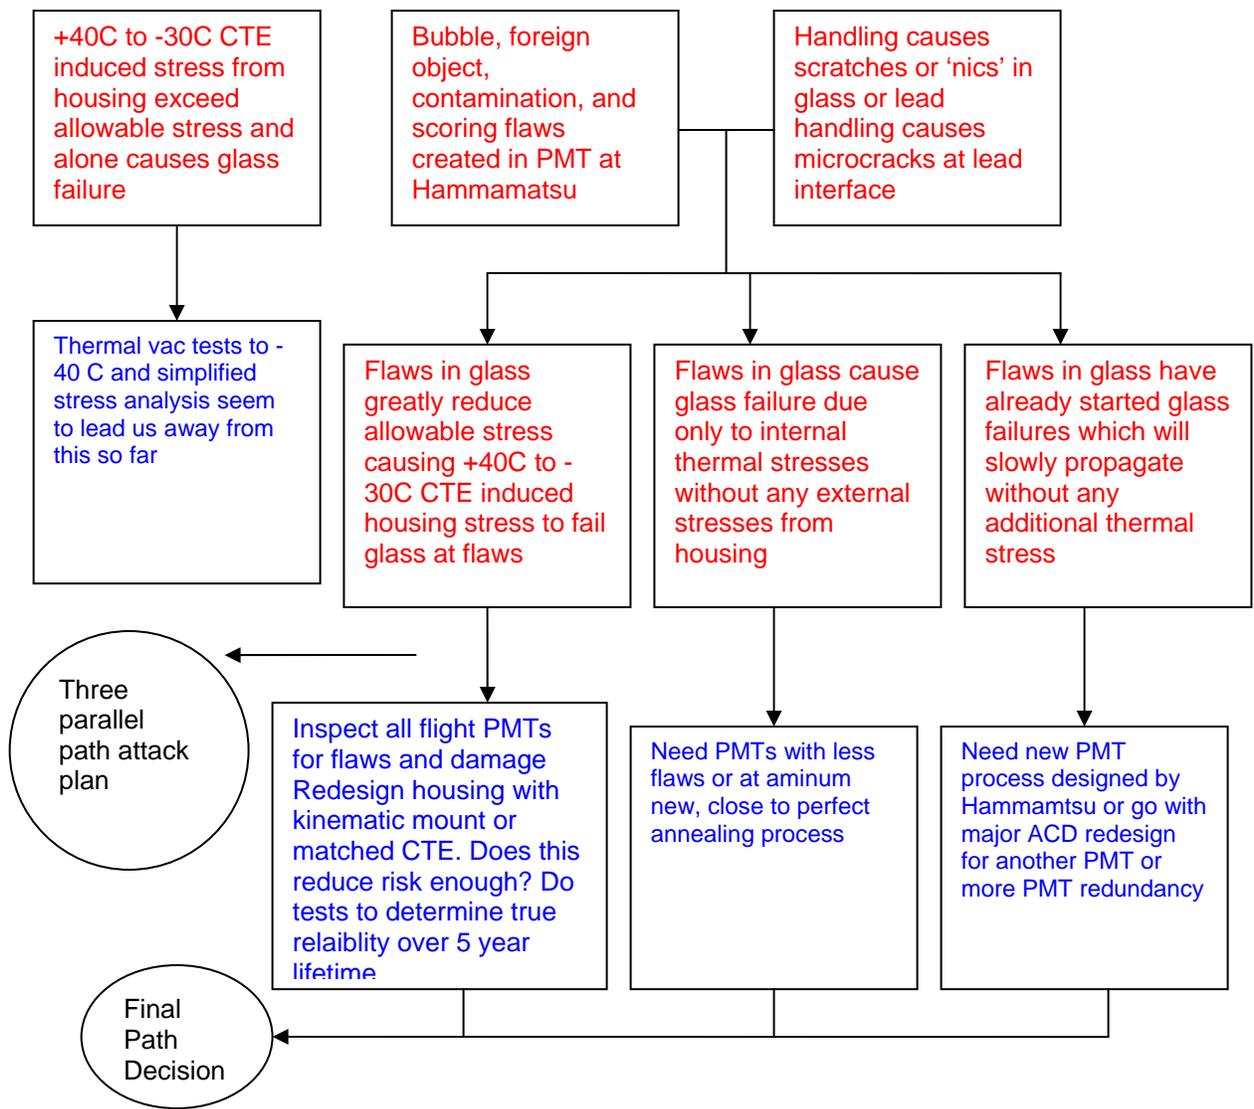
**Very early draft top level Fault/DecisionTree – next page**

Flight PMTs have at least some bubbles in glass in window transition, a more serious flaw has been discovered upon inspection. This flaw is a score along the inside of the tube all the way up almost certainly due to flex lead riding up tube during PMT internal electronics insertion. The broken PMT (46) was inspected and the visible part of the crack is at the same orientation as the score would be on that tube. The first failed tube that underwent excess clamping force was also inspected to check for the score. It was there and the crack in that PMT originated from the score. This does not prove the failure originated at the score, we will need to remove the PMT successfully possibly prove that
